PROCEEDINGS OF
THE INSTITUTION OF
CIVIL ENGINEERS

VOLUME 5 • FEBRUARY 1956 • NUMBER 1

PAGE
"SELECTED ASPECTS OF THE GEOMETRIC DESIGN OF AIRPORTS." J. H. Jones (with discussion)	1
"THE FAILURE AND REPAIR OF RIDHAM DOCK." R. G. T. Lane and G. T. Gregorian (with discussion)	26
"USES OF AERATED CEMENT GROUT AND MORTAR IN STABILIZATION OF SLIPS IN EMBANKMENTS, LARGE-SCALE TUNNEL REPAIRS, AND OTHER WORKS." M. C. Purbrick and D. J. Ayres (with discussion)	52
"THE NEW SLIPWAY AT BEAUMARIS." (Abs.) P. F. Stott	85
"PNEUMATIC AND SIMILAR BREAKWATERS." (Abs.) J. T. Evans	91
Correspondence on Paper No. 8018 (Pearsall)	94
"THE PLANNING OF RING ROADS, WITH SPECIAL REFERENCE TO LONDON." F. A. Rayfield (with discussion)	99
"RECONSTRUCTION OF THE GALLIONS LOWER ENTRANCE LOCK AT THE ROYAL DOCKS OF THE PORT OF LONDON AUTHORITY." J. A. Fisher (with discussion)	136
"CONSOLIDATION OF BALLAST." I. G. White (with discussion)	170
"THE OXTON BY-PASS EXTENSION." R. A. Kidd (with discussion)	200
"DESIGN OF SHIPS FROM THE CARGO HANDLING POINT OF VIEW." J. A. H. Lees	241

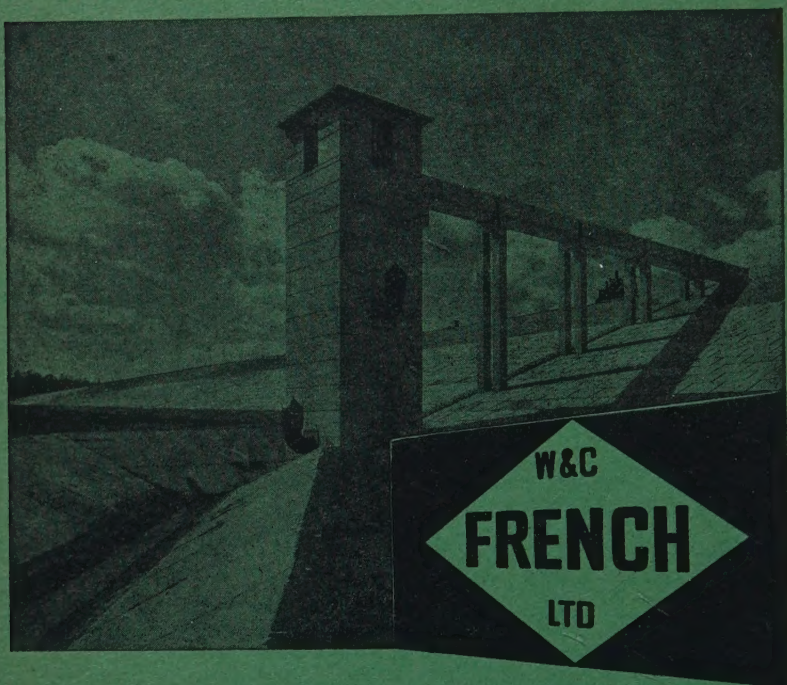
The Hilfield Park Reservoir, recently completed for the Colne Valley Water Co., was constructed by W. & C. French, Ltd.

Photograph shows the valve tower and channel which leads to the deepest part of the reservoir.

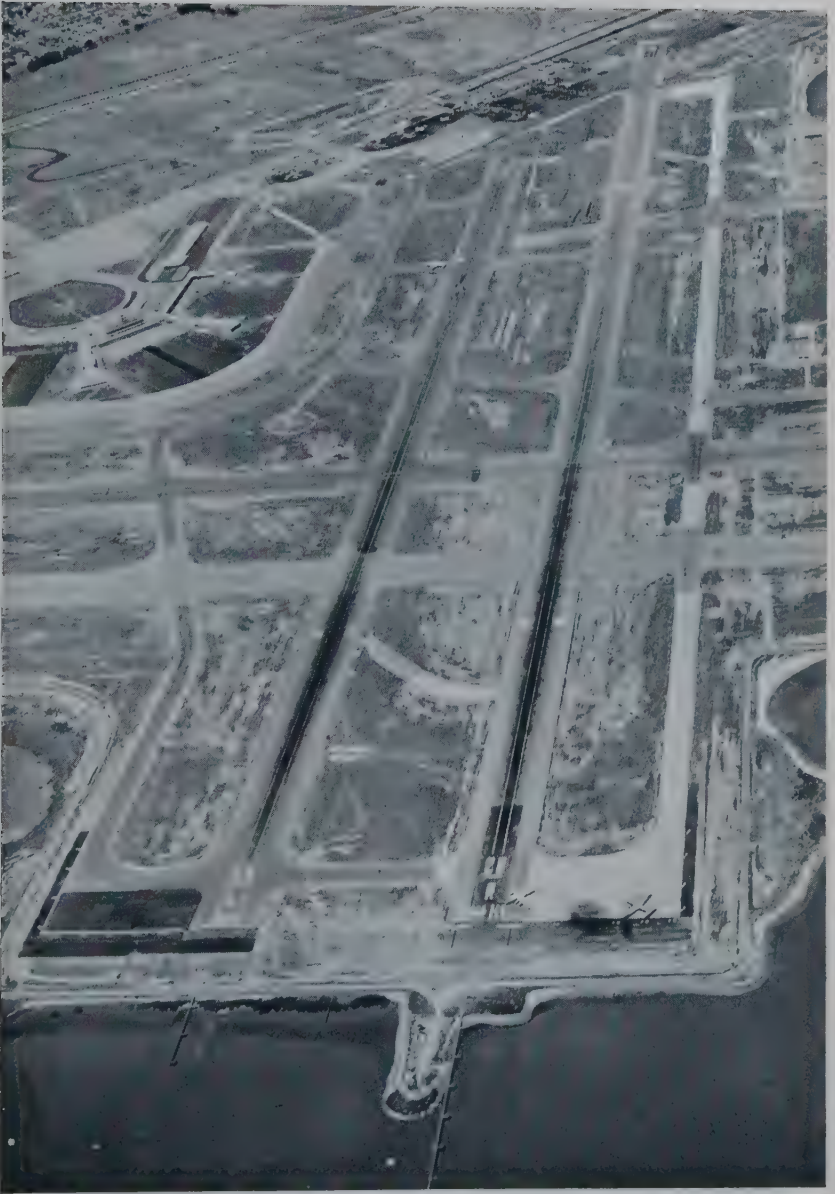
It is common practice to make the thickness of airport runway pavements uniform across the width of the runway. Observation of skid marks indicates, as shown in Fig. 1, that traffic on the runway is fairly well centred. To determine the actual transverse distribution of traffic at civil airports and to relate this distribution to pavement thickness a study was undertaken at three principal airports in California. The Los Angeles, Oakland, and San Francisco airports were selected for study. At each airport traffic was observed and compared for day and night operations under both visual and instrument flight conditions. The transverse distributions were determined at three locations on the runway by means of electrical traffic-detector tapes. The tapes, located at 600, 1,000, and 1,800 ft from the threshold of the runway, were capable of determining the transverse position of a wheel to within 10 ft. From the distribution of wheel loads an attempt was made to develop a design for runway pavement of varying thickness.¹

FIG. 1.—SAN FRANCISCO INTERNATIONAL AIRPORT SHOWING SKID MARKS ON THE RUNWAYS

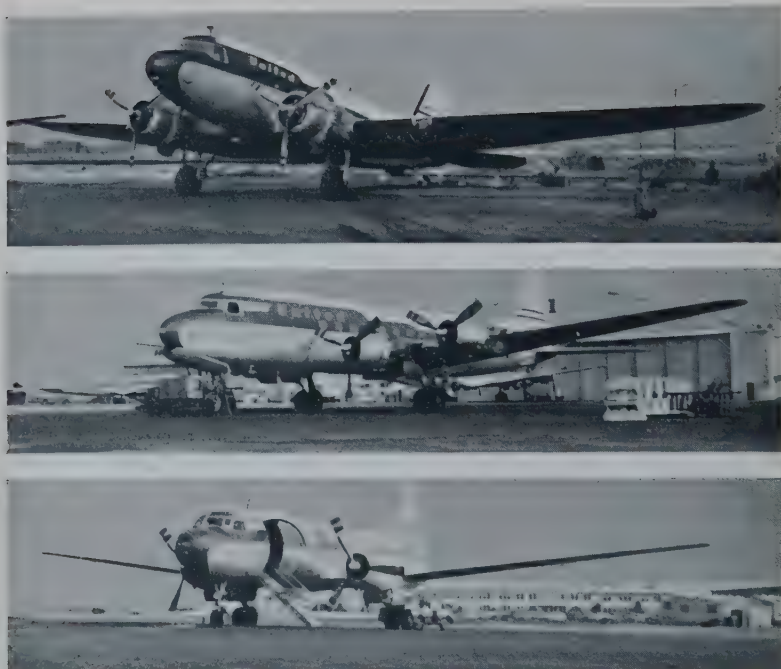
FIG. 11.—AIRCRAFT USED IN THE TESTS
 (Top) DOUGLAS DC-3
 (Centre) DOUGLAS DC-6
 (Bottom) CONVAIR CV-340

Three types of aircraft were used in these tests, the DC-3 and DC-6 manufactured by the Douglas Aircraft Corporation, and the Convair-340 manufactured by the Consolidated-Vultee Aircraft Corporation. These aircraft, shown in Fig. 11, are currently used for commercial operations throughout the world. Maximum gross take-off weights for the aircraft are: DC-3 25,000 lb., Convair-340 47,000 lb., and DC-6 92,000 lb.

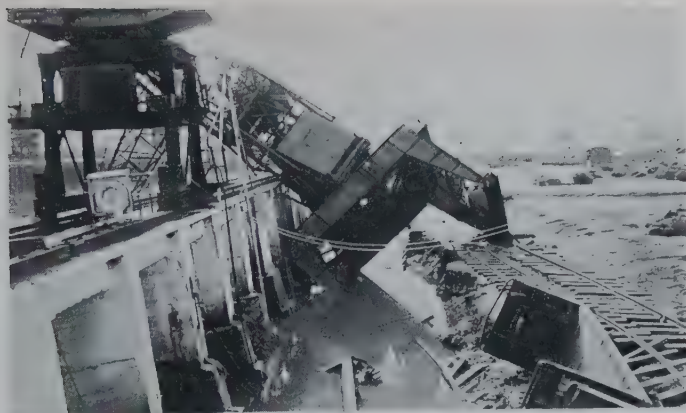
FIG. 6.—THE WEST WALL AFTER THE FORWARD MOVEMENT HAD CEASED
(The pulp-stacking crane has collapsed. The view was taken on 16.2.53 before the breaches had been sealed. The area shown here is on the river side of a temporary clay bank wall made to limit the area of flooding)

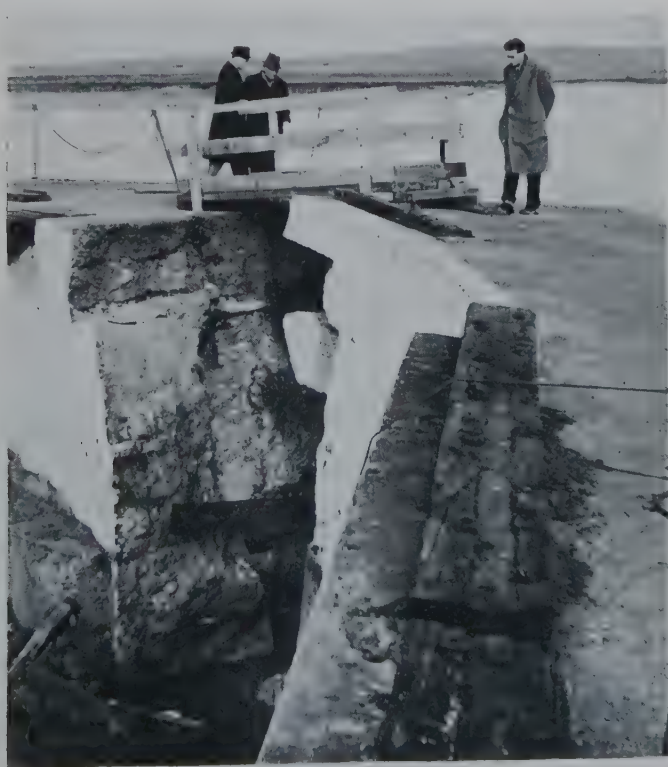
FIG. 7.—THE BREACH AT THE NORTH END OF THE WEST WALL

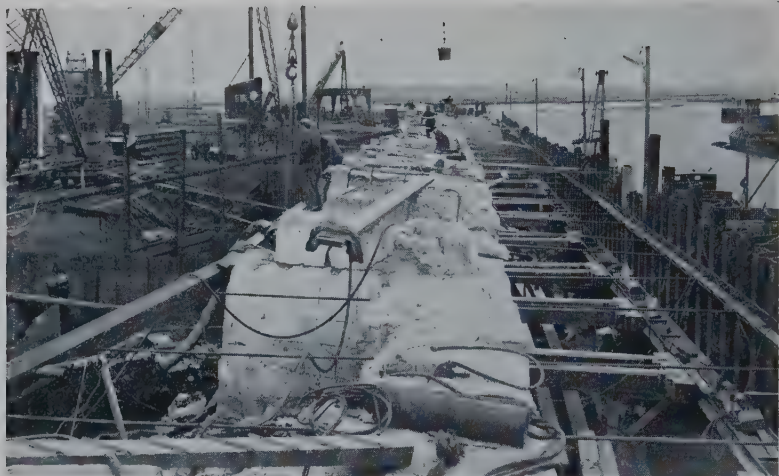
FIG. 14.—DEMOLITION IN PROGRESS AT THE SOUTHERN TEMPORARY BERTH
(4 MAY, 1953)

The first operation on the old wall was to remove the fenders and cut away the deck concrete to allow the piling on the waterside to be driven with as little encroachment as possible. When driven the piling was supported from and tied to the old wall with temporary struts and ties. It was sealed to the south dock wall and to the tilted west wall at a point 360 ft from the south end using concrete placed under water between timber shutters. This formed a cofferdam behind which trenches could be excavated and cut through the concrete wall to 6-in. below R.D. level for the insertion of the permanent tie-rods (Fig. 14).

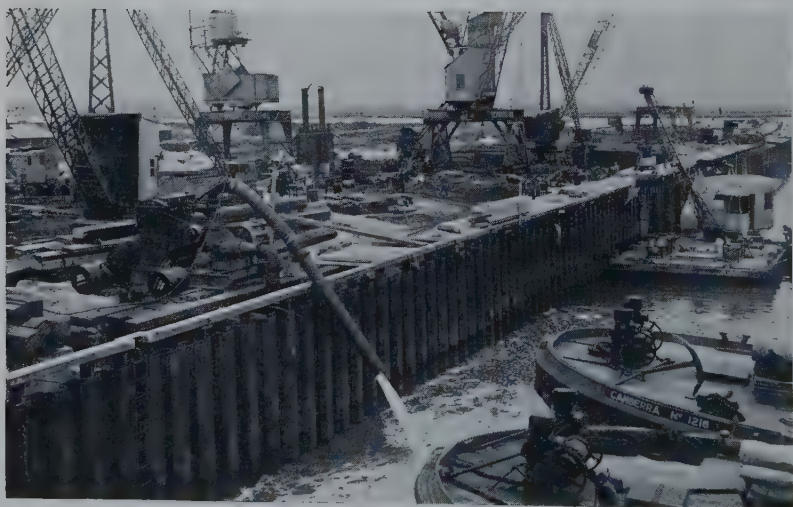
FIG. 15.—350 FT OF TEMPORARY QUAY NEARLY COMPLETE
(29 MAY, 1953)

It is satisfactory to record that the temporary quay 350 ft long was completed ready to receive ships on the 1st June, exactly 4 months after the damage occurred (Fig. 15).

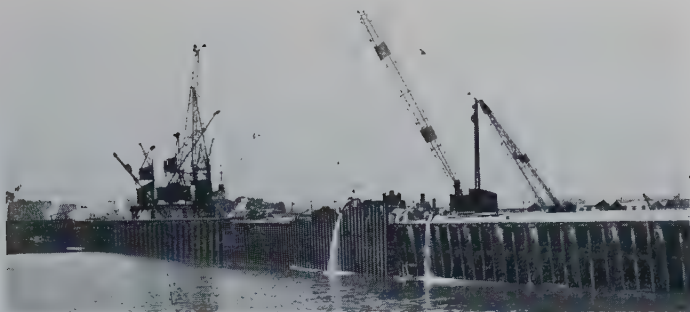
FIG. 17.—THE COMPLETED TEMPORARY BERTH WITH SHEET-PILING, CONTINUED TO FORM COFFERDAM ENCLOSING THE JUNCTION OF THE TWO BERTHS (1 SEPT., 1953)

One of the more difficult operations was the construction of the cofferdam required to hold out more than 40 ft of water during the cutting of the trench across the wall to allow the continuous line of 55-ft sheet-piling to be driven (Fig. 17). On the water side a junction pile was driven and the line of piling was continued temporarily for a distance of about 120 ft and sealed to the concrete with puddled clay retained between timber. From junction piles in the rear piling, bulkheads were driven and brought up to the concrete and sealed to it on both sides of the line of the trench using puddled clay. The back piling forming the cofferdam was driven to a top level of ± 14.0 R.D. and included a special junction pile to allow the piles crossing the wall to be in a continuous line across the cofferdam and beyond. The trench was cut using compressed-air-operated breakers. It proved difficult to pump out and keep the cofferdam dry (Fig. 18).

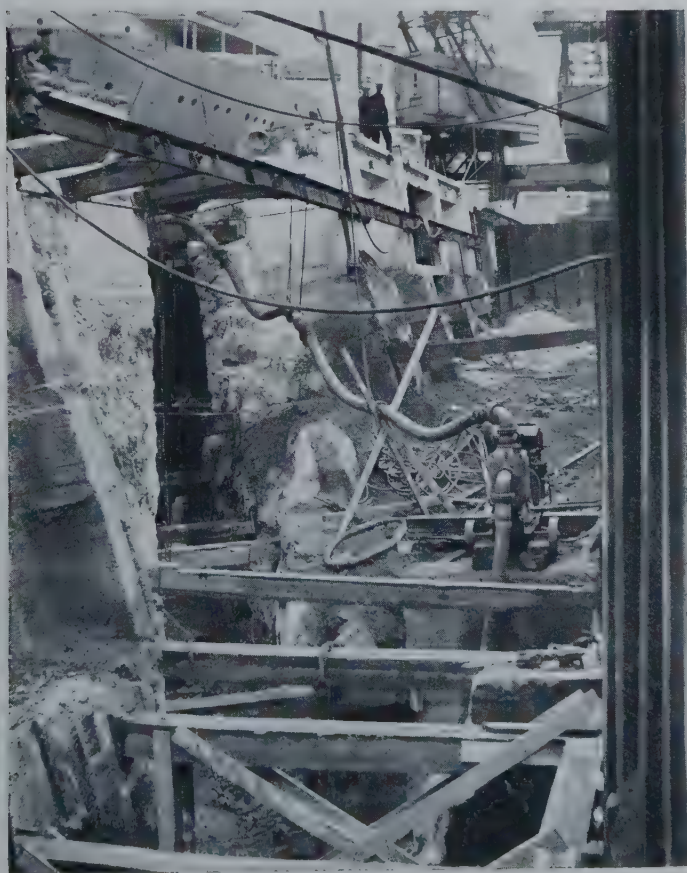
FIG. 18.—VIEW WITHIN THE COFFERDAM SHOWING THE TRENCH CUT THROUGH THE OLD CONCRETE WALL FOR STEEL SHEET-PILING

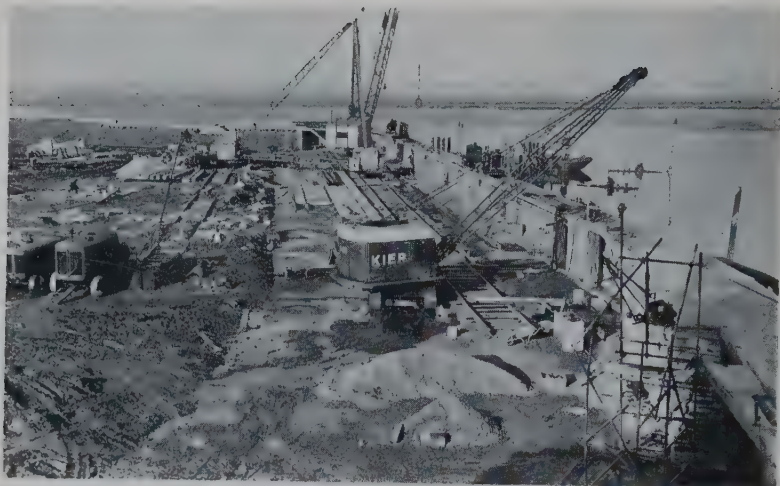
FIG. 19.—NEW NORTH BERTH NEARING COMPLETION
(5 Nov., 1954)

A concrete haunch stiffens and supports the dock-side piles to level 0.0 R.D. and is taken up as a wall to support the cantilever deck, 6 ft wide at level 17.50 R.D. (Fig. 19).

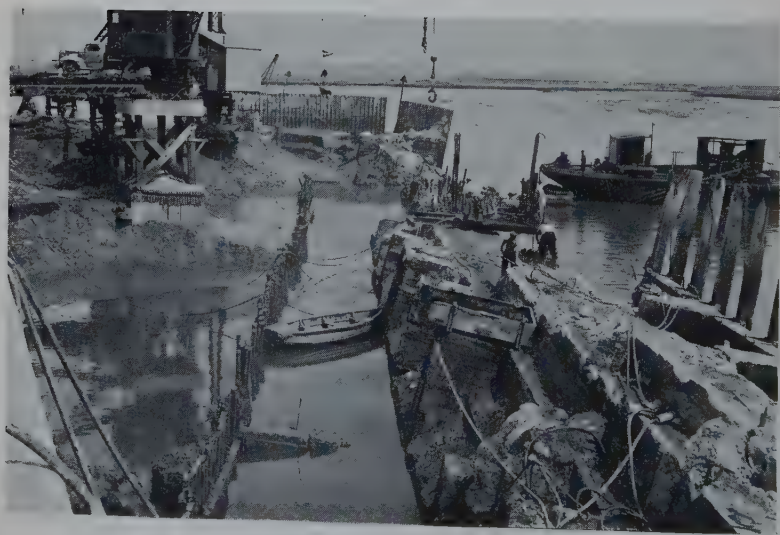
FIG. 20.—DEMOLITION OF OLD CONCRETE. NORTH END OF NEW QUAY ON LEFT
(7 May, 1954)

Outside the north quay the old wall had to be demolished under tidal conditions to below bed level of the new berth. It was agreed that the level of the new berth need not be lower than -14.0 R.D., rising to -12.0 R.D. beyond the dock to meet the river channel at this level, but demolition had to be taken lower to allow for future deepening of the dock to -19.0 R.D. The concrete has been removed down to -20.0 R.D. where within 55 ft from the new quay line, and to -17.0 R.D. over the rest of its area where ships will not be grounded (Fig. 20).

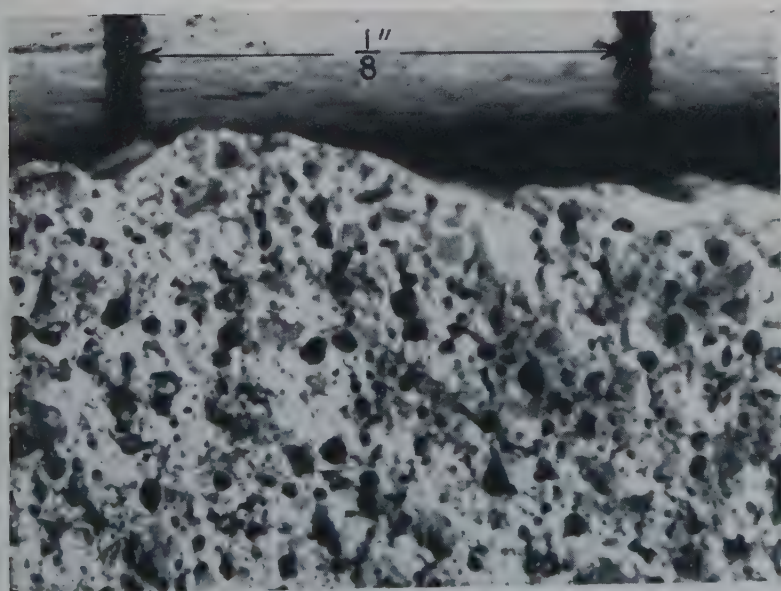
(a) POINTING MIX

(b) RENDERING SPRAYED AT HIGH AUXILIARY AIR PRESSURE

FIG. 1.—ENLARGED SECTION OF CONCRETE SPECIMENS

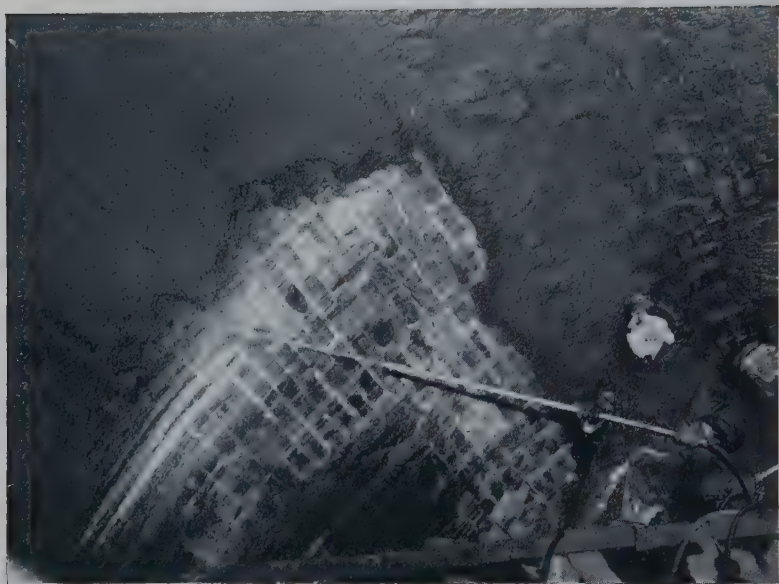
FIG. 10.—WASHING DOWN BRICKWORK

However, a very simple method of cleaning down has been developed using a high-pressure jet of water to which a non-ionic detergent of low foaming power has been added (1% by volume). See Figs 10 and 11, between pp. 72, 73.

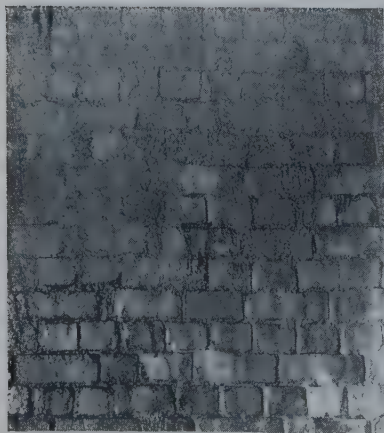
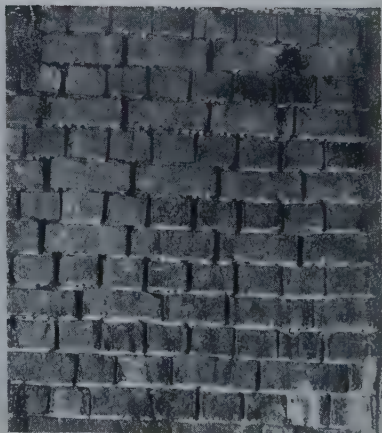
FIG. 11a.—BEFORE WASHING

FIG. 11b.—AFTER WASHING

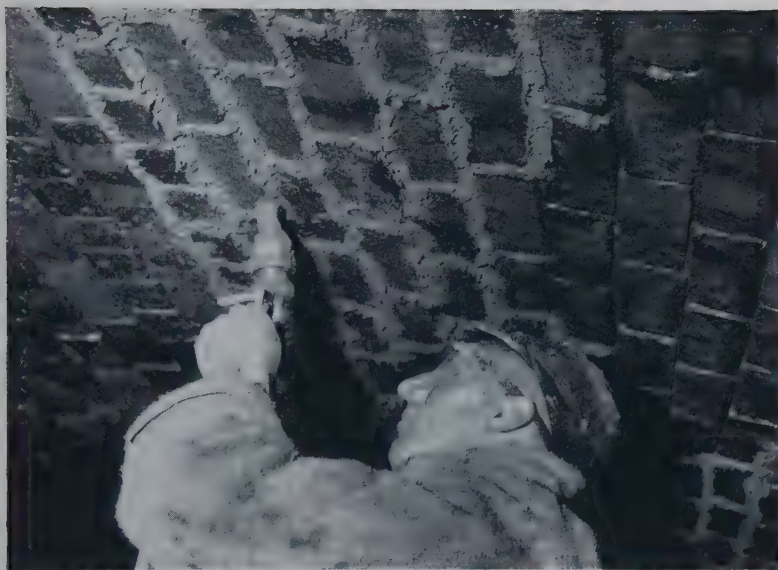
FIG. 13.—OVERHEAD POINTING—FULL JOINTS AND COMPLETE ADHESION

worker after training and practice. Since the mortar is directed between the bricks the individual masses are thrown to the back of the joint, where they build up one upon the other until the joint is filled. This is the opposite to hand pointing where mortar is pushed from the face of the brick towards the back of the joint, which it may not always reach. The same rate of working obtains for overhead as for side wall pointing (Fig. 13) and a slight increase of secondary air pressure is required to give the increased momentum to the mortar. Greater application of secondary air pressure produces a fierce spray which, by destroying some of the aeration, results in a higher-density material, which can be built up if necessary in very wide joints in overhead brickwork.

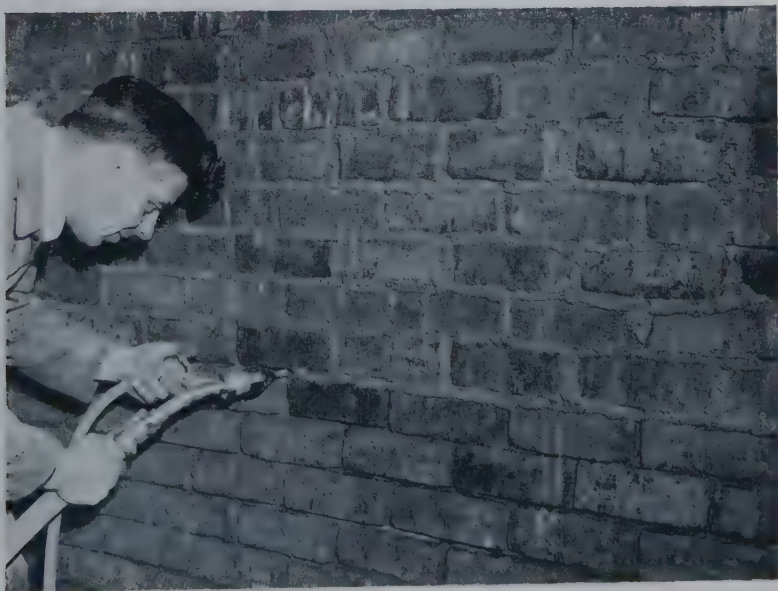
FIG. 14.—FINISHED PORTION OF VERTICAL WALL

The finish that is obtained by an experienced operator looks not unlike welding (Fig. 14) and requires no further attention unless appearance is important when, by use of a trowel or jointing tool, a normal finish can swiftly be applied.

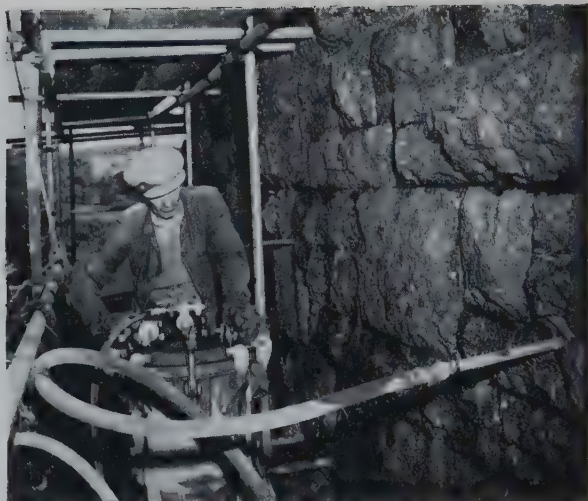
FIG. 16.—GROUTING A PIER AT CORNWOOD VIADUCT

The aerated mortar used had a water content slightly higher than a pointing mortar and was applied through a pressure pot. The mortar was mixed at ground level and conveyed to the pot on the scaffolding at the level of the grouting holes, Fig. 16, thus eliminating the extra pressure that would be required to overcome the static head and pipe losses. Pressures of up to 22 lb/sq. in. only were used and 2 cu. ft (i.e., one pot) was injected in $1\frac{1}{2}$ min; this was sufficient to keep up with the rate of hole drilling.

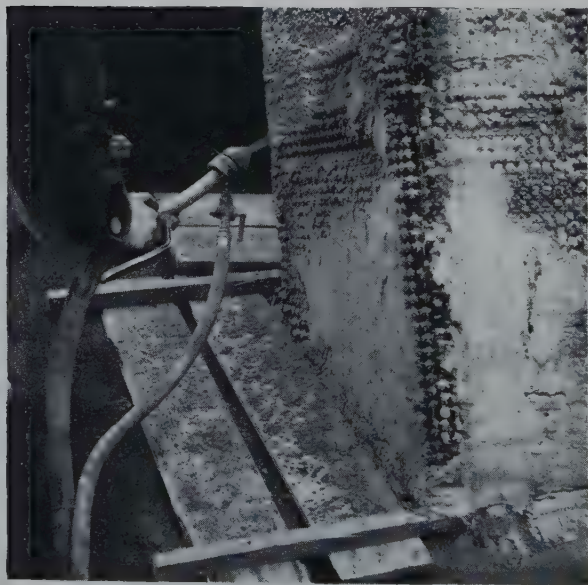
FIG. 17.—SPRAYING SMOKE CHUTES ON LOCOMOTIVE SHED ROOF

Aerated mortar has also been employed in the reconstruction of engine-shed smoke-shutes and ducts. The smoke-shutes were originally asbestos-sheeting on mahogany framing, and although the asbestos had deteriorated the framework was sound. In place of the asbestos, which had not given a satisfactory life, lathing was fixed on the timber and a $\frac{3}{8}$ -in. coating of aerated mortar sprayed on both sides (Fig. 17).

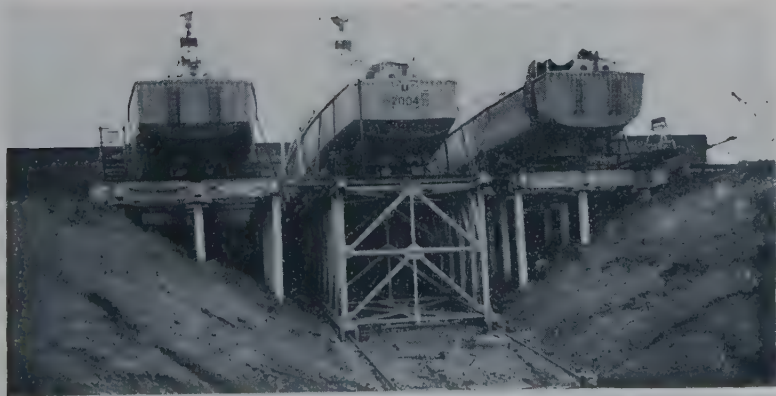
FIG. 3.—SHUTTLE CARRIAGE AND HARDSTANDINGS

- (1) Each traversing bogie is designed to carry half the weight of the largest ship, i.e., 150 tons. A unit weighs $3\frac{1}{2}$ tons and is arranged to break down into sections light enough to be manhandled into position and bolted up underneath a completed hull while it is still on its blocks.
- (2) The launching carriage, weighing $33\frac{1}{2}$ tons, is generally of riveted construction. In the design of the cross-members carrying the traverse rails it was assumed that the maximum load on a group would not exceed half the weight of a 300-ton ship uniformly distributed over the three members.
